2012 ASBESTOS HAZARD EMERGENCY RESPONSE ACT (AHERA) 3-YEAR RE-INSPECTION REPORT

SERRANO MIDDLE SCHOOL
4725 SAN JOSE STREET
MONTCLAIR, CALIFORNIA 91763

Project Number EE 12-Z0151-0010
March 30, 2012

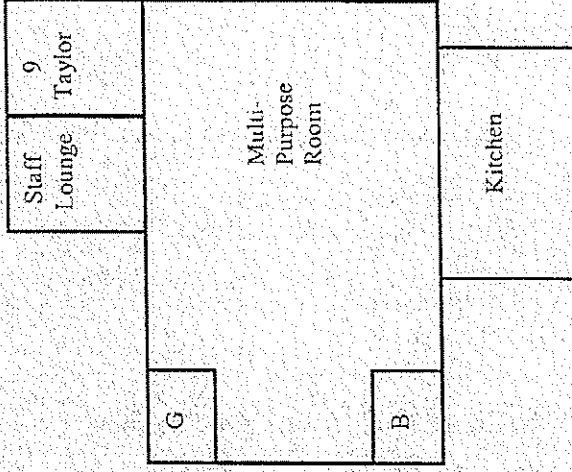
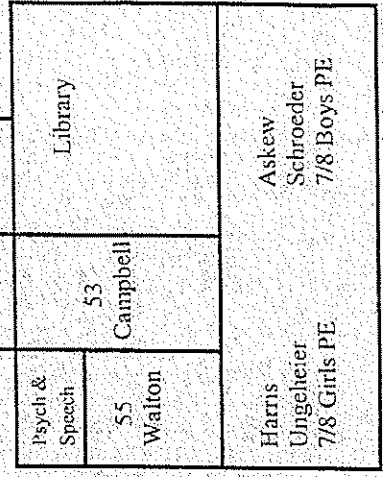
21	Sparky's
Kaumeyer	22 Anderson
23 Wolfe	24 Arcf
25 Hampton	26 Scott
27 Skove

41	Student Services
Chapman	42
43	Kodama
Cervantes	44
45	Cox/Barbec
Gannon

36	35	34	33
VanAlstine	Megaw	Howarth	Gideon
	7 th Lab	8 th Lab

G	32	31	B
	Yeh		Cust.
OH			Staff
B			G

67	66	65	64	63
Open	Montes	Swartz	DeLuca	Hansher

- I. EXECUTIVE SUMMARY
- II. SURVEY RESULTS REPORT
- III. SITE MAP
- IV. INSPECTOR'S CERTIFICATIONS
- V. DISCLAIMER/REPORT LIMITATIONS
